DEVON COUNTY COUNCIL - ASBESTOS SURVEY REPORT

Property : 0604

BRADWORTHY COMMUNITY PRIMARY SCHOOL
MILL ROAD
BRADWORTHY
DEVON
EX22 7RT
01409 241365

Initial Type 2 Survey by : Ethos Environmental on : 12/01/2005, 28/02/2005

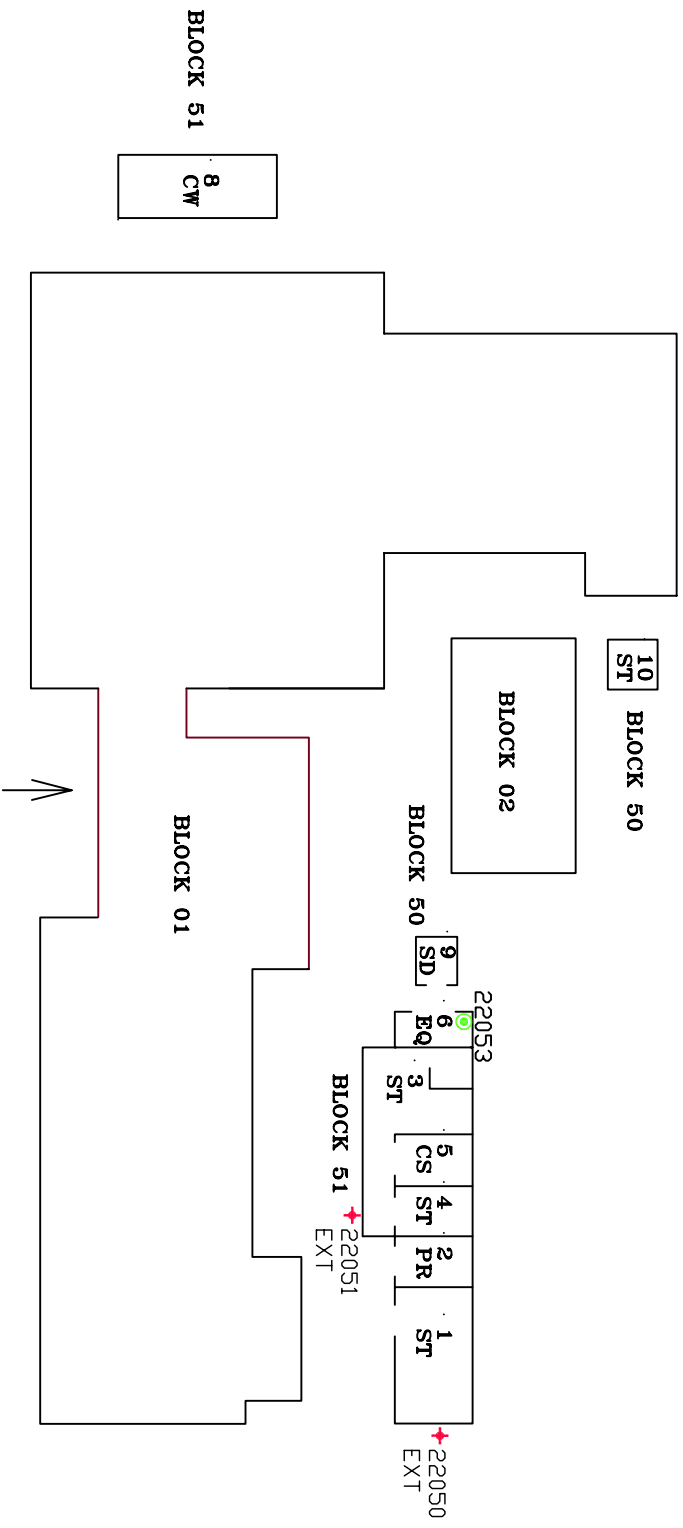
Title: **BRADWORTHY COMMUNITY PRIMARY S ASBESTOS SURVEY AREAS**

Area contains asbestos components. Consult schedule.

Amendments
 Block 01 room 10 merged with room 11 2002.
